## STRUCTURAL INVESTIGATIONS ON THE PROGRESSIVE COLLAPSE OF A STEEL-TIMBER INTERMEDIATE ROOFING

Calin NEAGU\*, Dan DUBINA\*,\*\*, Florea DINU\*,\*\*, Ioan PETRAN\*\*\*

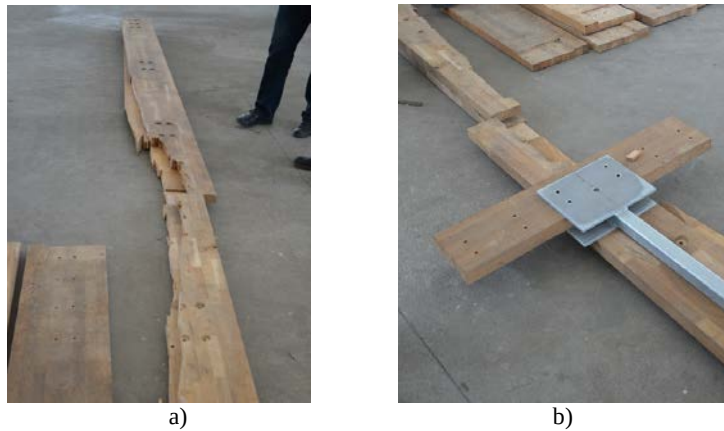
During a visit at the construction site after the accident, sections of the beam that initially failed were identified and assembled to reconstruct the beam (Figure 5.a). The reconstruction revealed that the fracture had occurred at the splice connection between sections T1 and T2 of the beam (see Figure 6 for identification of the beam sections). There was no evidence of any damaged or broken link. However, one such element was identified as the most probable part of the failed connection, as it exhibited localized tear-out damage in the first row of bolts (Figure 5.b).

Figure 5: Two sections of the beam reconstructed after the failure: a) view with the elements on the ground; b) connecting device with the post, two gusset plates, and timber link element

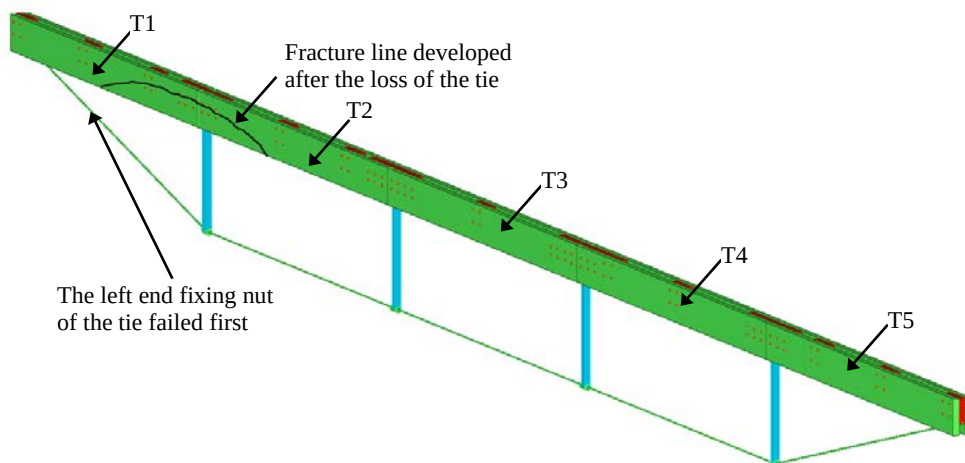
Figure 6: The initiation of collapse in beam from axis 3, between section T1 and T2 (the fracture line is also sketched)

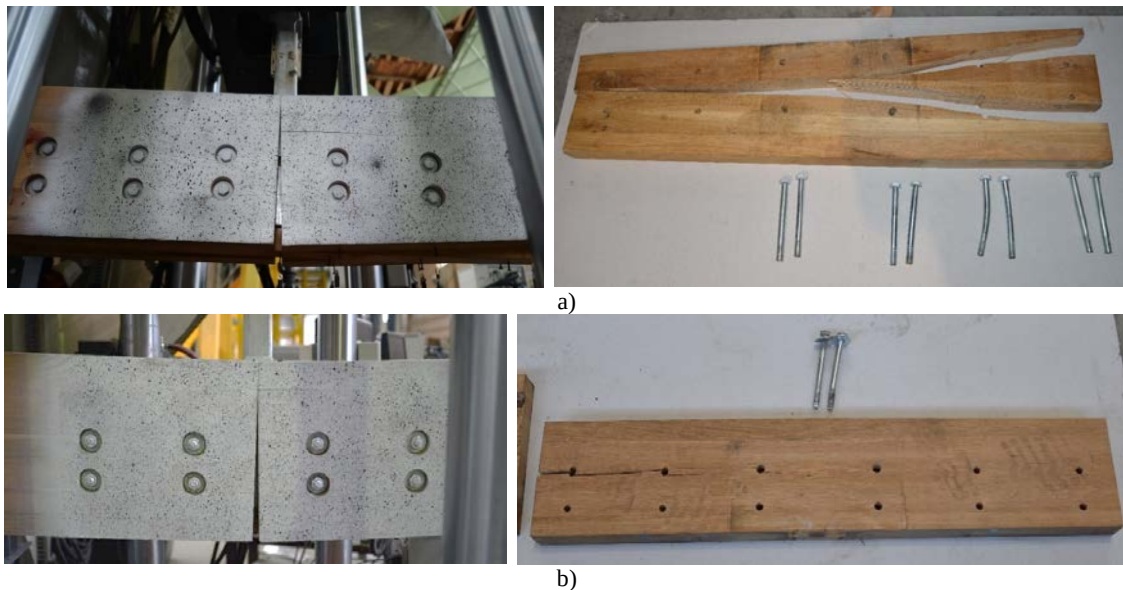
Figure 9.a shows the force-displacement curves for specimens S1 and S2, while Figure 10 shows the failure mode for the same specimens. In case of specimen S1, a partial failure (most probably a partial split of the timber link) was observed at a force equal to 24,4 kN, where it dropped to 13,10 kN. Subsequently, the capacity increased until the final fracture of the link element owing to a complete split at a maximum force of 30,5 kN (Figure 10.a). This failure mode, also called “zip-effect”, appears when a splitting-failure of one fastener makes the subsequent fasteners in a row to fail. The bending moment at the maximum applied force was 25,10 kNm. Only a partial longitudinal crack was observed in the upper area of the beam elements because of compression, a crack that propagated longitudinally up to the second bolt row. It is also visible in the figure that the deformation of the bolts is larger in the second bolt row from the right-hand area, indicating an uneven transfer of shear loads within the hybrid steel-timber connection. In case of specimen S2, the peak applied force was 29,70 kN, very close to that obtained for specimen S1, and the corresponding bending moment was 24,40 kNm. The splitting of the link element within the larger span caused the failure as shown in Figure 10.b. Only partial cracks developed in the upper area of the beam upon compression.

Figure 10: Failure mode: a) specimen S1; b) specimen S2

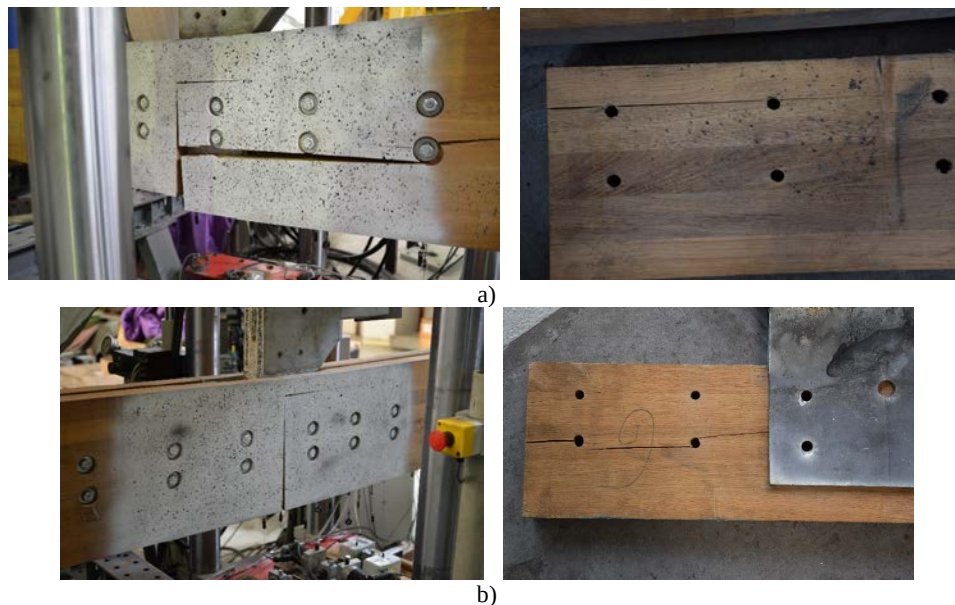
the cracks first initiated in the upper compressed area of the beam, which then propagated up to the second bolt row; however, they did not cause a significant decrease in the beam capacity. The failure was produced owing to the splitting of the beam from the larger span (Figure 11.a). The maximum force was 31,6 kN, after which the capacity dropped sharply to 20 kN. The test was terminated when the vertical displacement reached 78 mm. The maximum bending moment was 33,80 kNm. No cracks were observed in the link element. As the fracture developed in the beam elements and not in the link, it was possible to observe the initiation and propagation of the cracks in the connection up to the failure point. Thus, the initiation started inside the beam, between the second and the third bolt row, after which it propagated beyond the second bolt row and finally the failure was caused by the beam splitting, as seen in Figure 12. In case of specimen S4, the first crack formed in the upper compressed area of the beam, which then propagated up to the second bolt row; however, it did not produce a significant decrease in the beam capacity. Splitting of the link element from the larger span for almost half the length caused the failure, as seen in Figure 11.b. The maximum force value was 32,9 kN, after which the capacity dropped sharply, and the test was terminated. The maximum bending moment was 35,2 kNm.

Figure 11: Failure mode: a) specimen S3; b) specimen S4

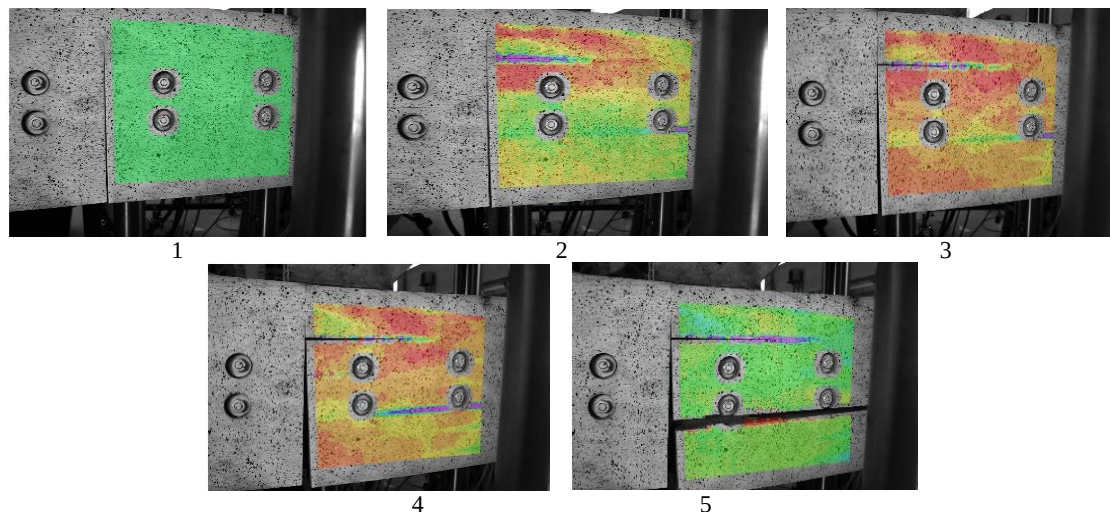
Figure 12: Initiation and development of cracks measured with VIC-3D system, specimen S3 (from 1 to 5)

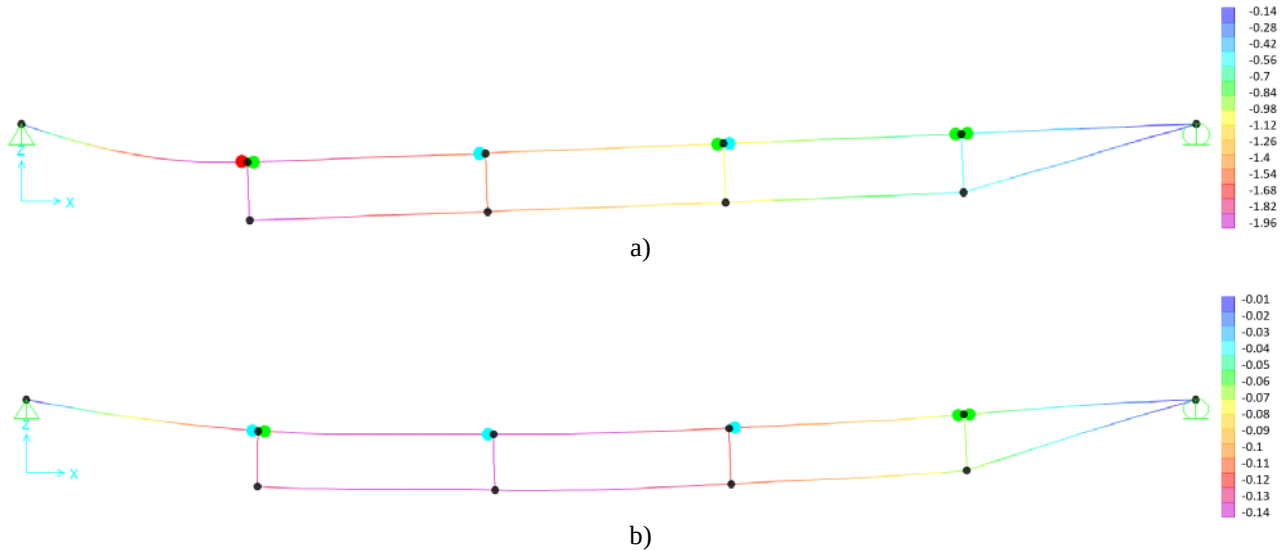
As seen from Figure 15.a, after the tie is lost, the timber beam alone cannot support the applied gravity loads and fails at the first intermediate splice. Notably, the same point of fracture was identified on the site (Figure 5.a). Moreover, the instantaneous removal of the tie exposed the structure to a dynamic effect, and thus much greater loads were imposed on the structure. For comparison, Figure 15.b shows the deformed shape of the beam in the case of a quasi-static removal of the tie. Even when the vertical deflection reaches 148 mm, the bearing capacity of the connections is not exceeded, and the failure is prevented.

Figure 15: Deformed shape of the beam and distribution of plastic hinges in splice connections: a) removal time  $\Delta t = 0.001$  sec; b) quasi-static removal (the scale indicates the vertical deflection, in m)
