## STRUCTURAL INVESTIGATIONS ON THE PROGRESSIVE COLLAPSE OF A STEEL-TIMBER INTERMEDIATE ROOFING

Calin NEAGU\*, Dan DUBINA\*,\*\*, Florea DINU\*,\*\*, Ioan PETRAN\*\*\*

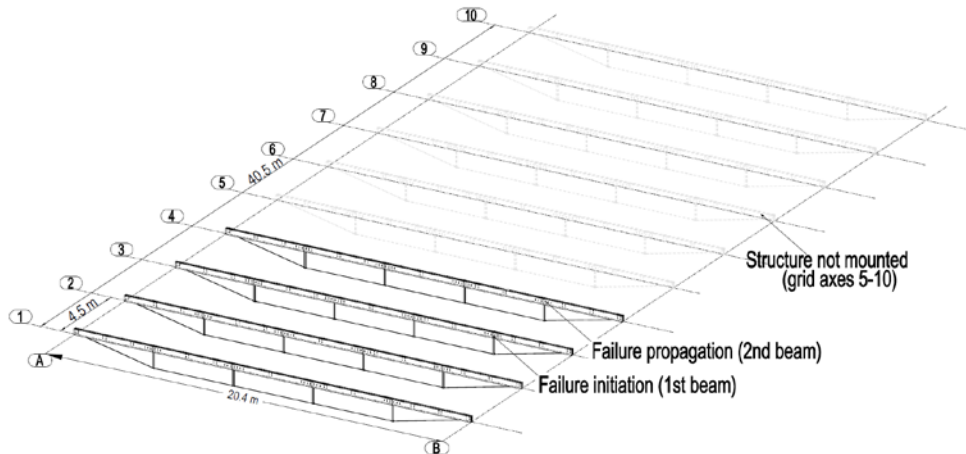
The structure under investigation was a new intermediate roof being built inside an existing open-air market located in Timisoara, Romania (see Figure 1). This intermediate roof was designed to protect the commercial space from severe weather conditions. The roof, constructed with glued laminated timber beams and steel posts and ties (Figure 2), partially collapsed during the erection phase when a transversal beam fractured and resulted in the failure of the adjacent beam (see Figure 1). The beams, with a total span of 20,40 m, comprised five sections joined on-site with a hybrid timber-steel bolted connection (see Figure 3). The supports at both the beam ends were pinned. The beam sections, denoted as T1 to T5, were of almost equal length (T1, T5 = 4,05 m; T2, T3, T4 = 4,10 m). Each beam section contained two individual beams (pair section), each 5 cm thick, joined at each splice connection. The timber beam was a symmetrical double-pitched beam with the following dimensions:

Figure 1: 3D view of the intermediate roof structure

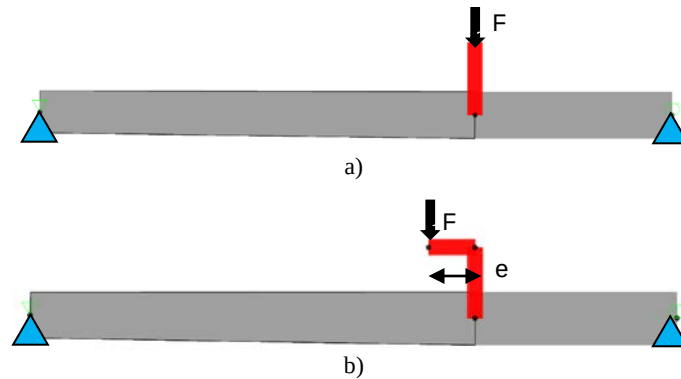
two spans, 2,85 m and 1,20 m, respectively. For specimens S1 and S2, the load was applied on top of the post (Figure 7.a), whereas it was applied with an eccentricity  $e$  of 0,35 m for S3 and S4 (Figure 7.b). The different loading setup aimed at evaluating the possible effects of bending/shear ratio on the peak capacity and failure mode.

Figure 7: Loading setup for experimental testing: a) specimens S1, S2; b) specimens S3, S4

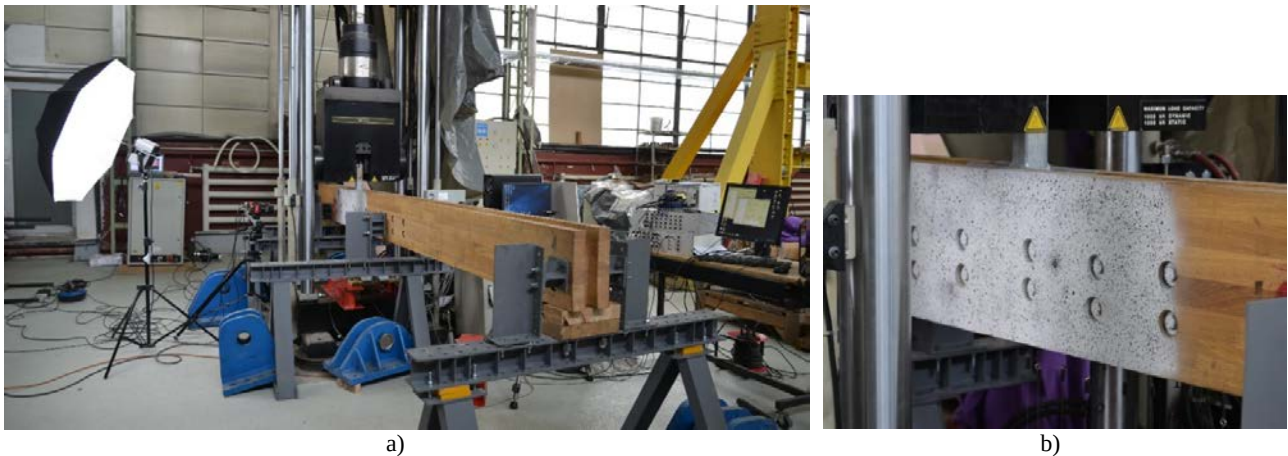
The vertical load was applied quasi-statically using a displacement control protocol and was gradually increased until the failure of the test specimens (Figure 8.a). The amplitude of the load was monitored using the load cell of the actuator. The instrumentation used during testing comprised two main components, namely, displacement transducers and a digital image correlation system produced by Correlated Solutions, Inc. (VIC-3D) [14] (Figure 8.b).

Figure 8: View from laboratory: (a) test setup and specimen ready for testing; (b) surface preparation for VIC-3D measurements

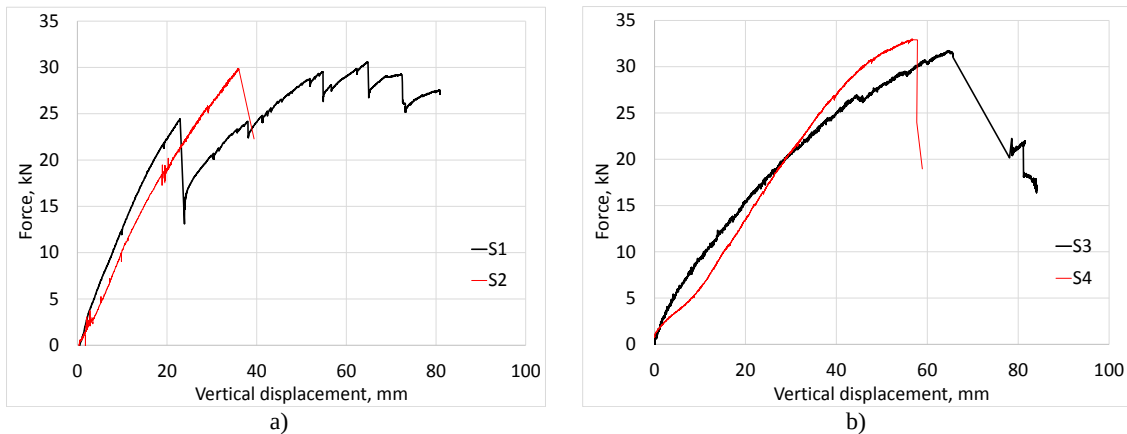
Figure 9.a shows the force-displacement curves for specimens S1 and S2, while Figure 10 shows the failure mode for the same specimens. In case of specimen S1, a partial failure (most probably a partial split of the timber link) was observed at a force equal to 24,4 kN, where it dropped to 13,10 kN. Subsequently, the capacity increased until the final fracture of the link element owing to a complete split at a maximum force of 30,5 kN (Figure 10.a). This failure mode, also called “zip-effect”, appears when a splitting-failure of one fastener makes the subsequent fasteners in a row to fail. The bending moment at the maximum applied force was 25,10 kNm. Only a partial longitudinal crack was observed in the upper area of the beam elements because of compression, a crack that propagated longitudinally up to the second bolt row. It is also visible in the figure that the deformation of the bolts is larger in the second bolt row from the right-hand area, indicating an uneven transfer of shear loads within the hybrid steel-timber connection. In case of specimen S2, the peak applied force was 29,70 kN, very close to that obtained for specimen S1, and the corresponding bending moment was 24,40 kNm. The splitting of the link element within the larger span caused the failure as shown in Figure 10.b. Only partial cracks developed in the upper area of the beam upon compression.

Specimens S3 and S4 were tested by eccentrically applying an increasing vertical force (eccentricity  $e = 0,35$  m). Figure 9.b shows the force-displacement curves for the two specimens. In case of specimen S3,

the cracks first initiated in the upper compressed area of the beam, which then propagated up to the second bolt row; however, they did not cause a significant decrease in the beam capacity. The failure was produced owing to the splitting of the beam from the larger span (Figure 11.a). The maximum force was 31,6 kN, after which the capacity dropped sharply to 20 kN. The test was terminated when the vertical displacement reached 78 mm. The maximum bending moment was 33,80 kNm. No cracks were observed in the link element. As the fracture developed in the beam elements and not in the link, it was possible to observe the initiation and propagation of the cracks in the connection up to the failure point. Thus, the initiation started inside the beam, between the second and the third bolt row, after which it propagated beyond the second bolt row and finally the failure was caused by the beam splitting, as seen in Figure 12. In case of specimen S4, the first crack formed in the upper compressed area of the beam, which then propagated up to the second bolt row; however, it did not produce a significant decrease in the beam capacity. Splitting of the link element from the larger span for almost half the length caused the failure, as seen in Figure 11.b. The maximum force value was 32,9 kN, after which the capacity dropped sharply, and the test was terminated. The maximum bending moment was 35,2 kNm.

Figure 9: Experimental force-displacement curves: a) specimens S1, S2; b) specimens S3, S4

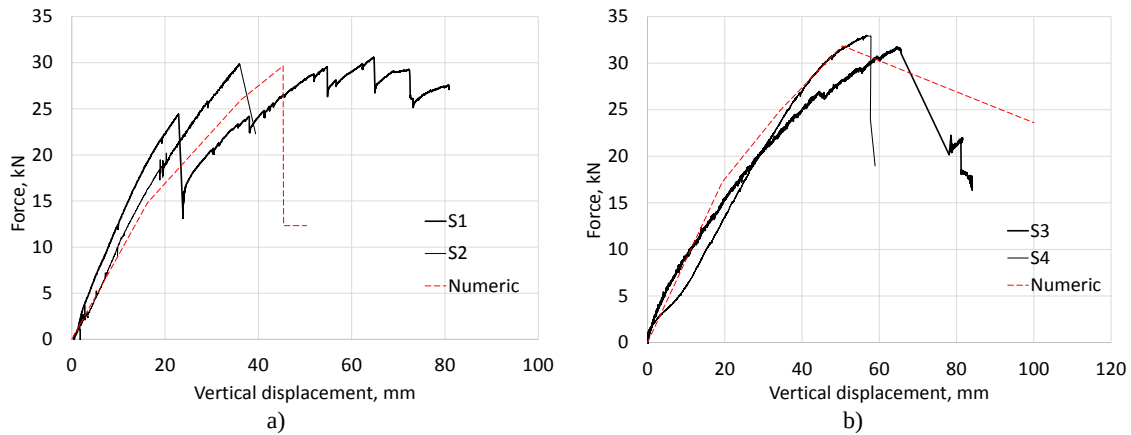
Numerical analyses were performed to evaluate the load bearing capacity of the beam assembly to identify the potential flaws in design and construction that caused the collapse. Numerical models for the connections were first constructed and calibrated based on the experimental results, using SAP2000 program [15]. The geometrical and material properties and the loading schemes complied with the laboratory conditions and the properties of the materials that were evaluated with experimental testing. Two types of frame hinges were assigned to the beam sections, that is, shear V2 and moment M3, both uncoupled. Figure 13 shows the comparative force-displacement curves in the nonlinear static analysis and experimental

testing. The numerical models accurately estimated the initial stiffness, maximum force, and corresponding maximum displacement.

Figure 13: Force-displacement curves, experimental vs. numeric: a) specimens S1, S2; b) specimens S3, S4

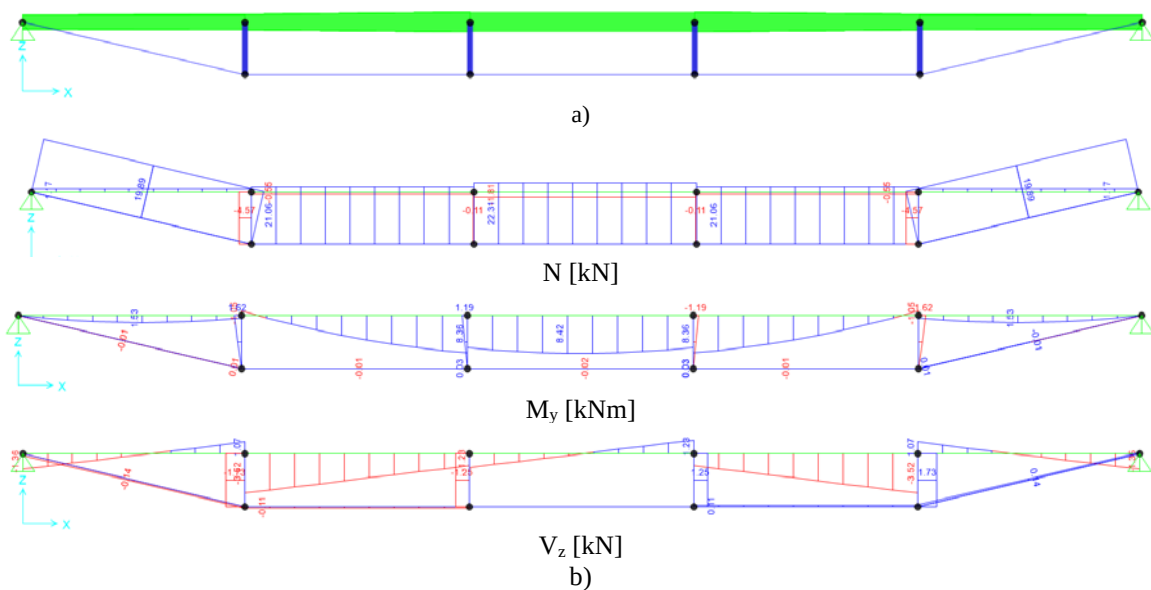
To determine the distribution of forces in the beam, a complete model of the beam assembly was obtained by integrating the joint models (Figure 14.a). The geometric and material characteristics were obtained from the technical project and the test report provided by Urban Incerc Timisoara (2017). Considering that the beam was not loaded with any imposed load at the time of collapse, the beam was first analyzed for the effects of gravity load caused by the self-weight of the beam assembly, which was then increased by 50% to account for possible deviations from the nominal weight and other materials/tools used during the construction stage. A static analysis was applied to determine the maximum values of forces and bending moments in the timber elements, steel post, and ties at the time of failure. As can be seen from Figure 14.b, the values of the bending moment and shear force are lower than the peak values recorded during experimental testing, which eliminates them as the source of failure. However, the axial force, which amounts to 19,89 kN, is higher than the minimum resistance measured for the threaded rods (13,38 kN). In these conditions, the failure most probably initiated from the steel tie, which failed suddenly in tension under the effect of the gravity load. To investigate the removal effect on the structure, a two-stage analysis was performed to assess if the complete structural collapse was triggered by the failed tie. In the first stage, the gravity load (multiplied by a safety factor of 1.5) was applied to the structure. In the second stage, the tie was removed almost instantly ( $\Delta t = 0.001$  sec). The response of the remaining structure was then evaluated using a non-linear dynamic time history analysis.

Figure 14: Hybrid timber-steel beam model in SAP2000: a) complete beam model; b) axial force, in-plane bending moment  $M_y$ , and shear force  $V_z$  under gravity loads due to self-weight
